# Design, Installation, and Post-Installation Performance Monitoring of a ZVI PRB in a Residential Neighborhood

Arun Chemburkar, Brian Bjorklund, Jim Warner, John Moe, ERM, Walnut Creek, CA; Kevin Dyson, PE, GeoSierra Environmental, Inc., Medford, NJ

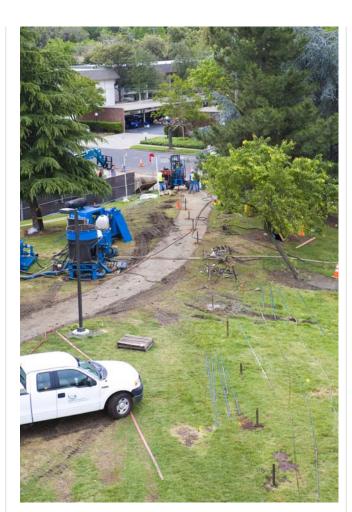
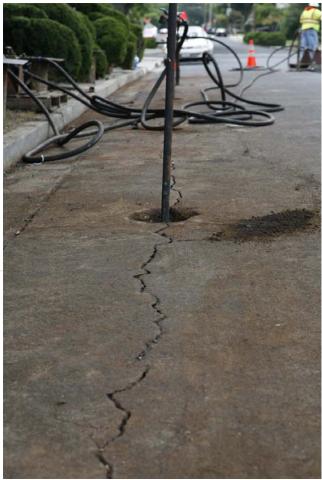
Frac casing alignments in park and street
