Groundwater Remediation **Iron Reactive Barriers**

Iron Reactive Barrier

Location: Montross, Virginia Year completed: 2002

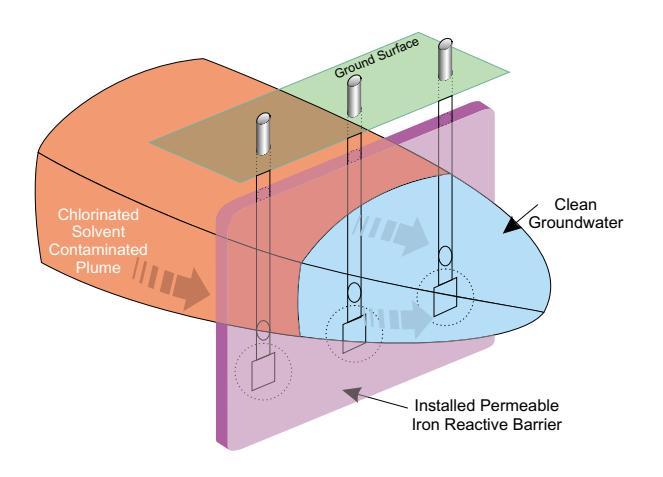
Azimuth Controlled Vertical Iron Reactive Barrier **Construction by Hydraulic Fracturing**

The iron reactive barrier system was installed by GeoSierra azimuth controlled vertical hydraulic fracturing technology. The site consists of silts and fine sands overlying an aquitard consisting primarily of clavs and silts. The iron reactive barrier was constructed in upper sands and silts and keyed into the underlying aquitard. The fine sands are characterized as loose flowing sands with a permeability of approximately 1 Darcy.

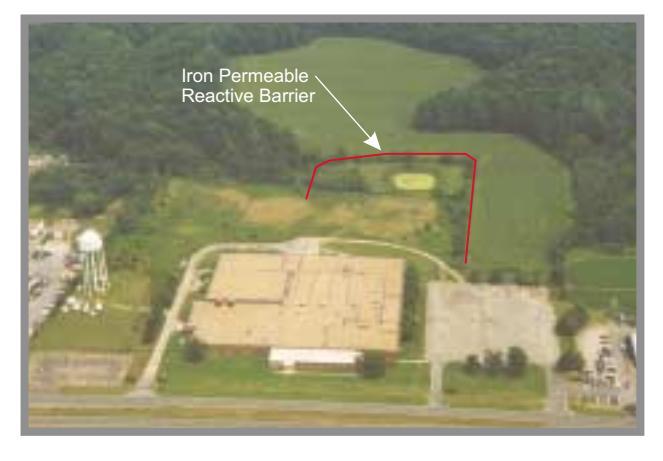
Aerial View of Iron Permeable Reactive Barrier

The iron reactive barrier was constructed from 82 frac injection wells and is over 1160 feet in length, ranging in depth from 5 feet down to a total depth of 44 feet below ground surface. The in situ iron reactive permeable barrier has the capacity to degrade extremely high concentrations of VOCs to below their MCL levels, as the groundwater flows naturally through the barrier. The VOC's in the presence of iron below the water table are progressively degraded to non-toxic end products such as ethene.

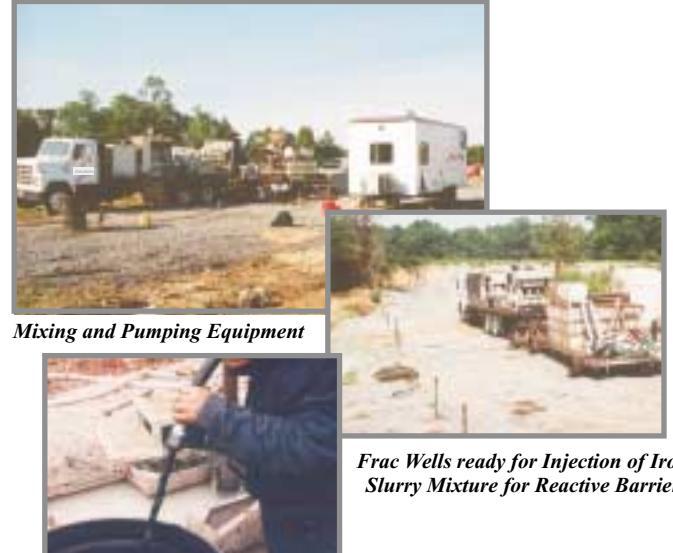
Injected Iron Slurry Mixture for Reactive Barrier

Frac Wells ready for Injection of Iron Slurry Mixture for Reactive Barrier
